SERVICE BULLETIN

PURPOSE : INFORMATION	ISSUE NO. : MSB-07E42-009	DATE : 2007-07-20
SUBJECT : REPLACEMENT PROCEDURE FOR WELDED PANEL AND INSTRUCTIONS FOR UNDERBODY ANTICORROSION AGENT	<div> <div><MODEL></div> <div>(EUR/Russia)</div> <div>OUTLANDER</div> <div>(GS45X)(CW0W)</div> </div> <div> <div><M/Y></div> <div>08</div> </div>	
GROUP : BODY

This Service Bulletin contains the following change and addition to the applicable Workshop Manual.

- According to the revision of the position to fill with the sound dampening foam material, the replacement procedure for the welded panel has been modified.
- The instructions for the underbody anticorrosion agent application have been added.

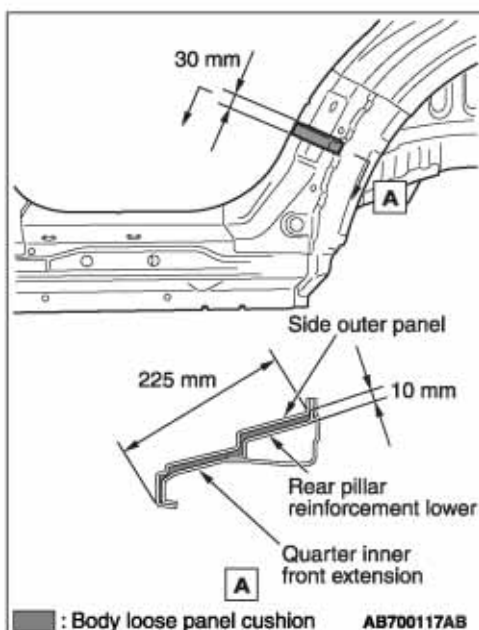
SIDE SILL

When installing the new floor side sill outer, the inside of wheel arch cannot be filled with sound dampening foam material, therefore, machine the body loose panel cushion (MR435765 or MR565301) shown in the figure as an alternative and adhere it.

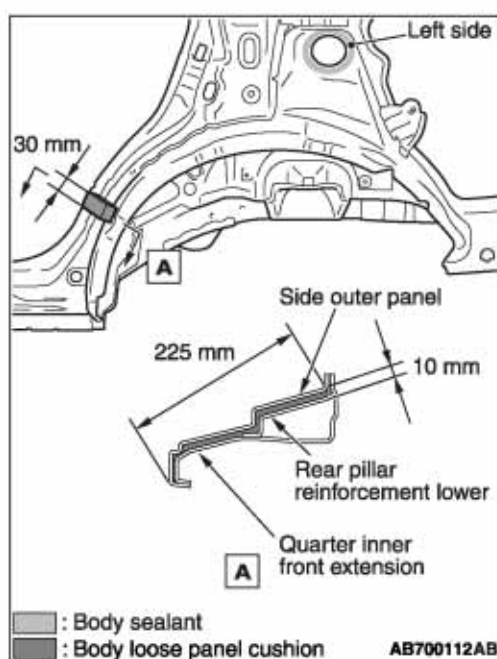
QUARTER OUTER

The position and the size of the body loose panel cushion that is installed when installing the rear quarter outer panel have been changed as below.

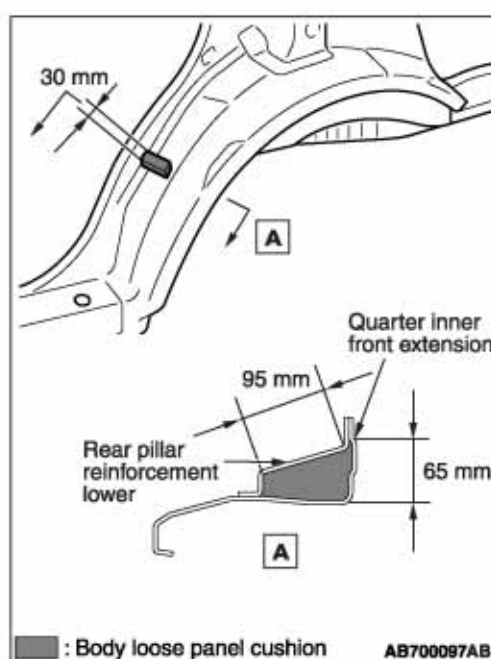
QUARTER INNER

The position and the size of the body loose panel cushion that is installed when installing the rear pillar reinforcement lower have been changed as below.

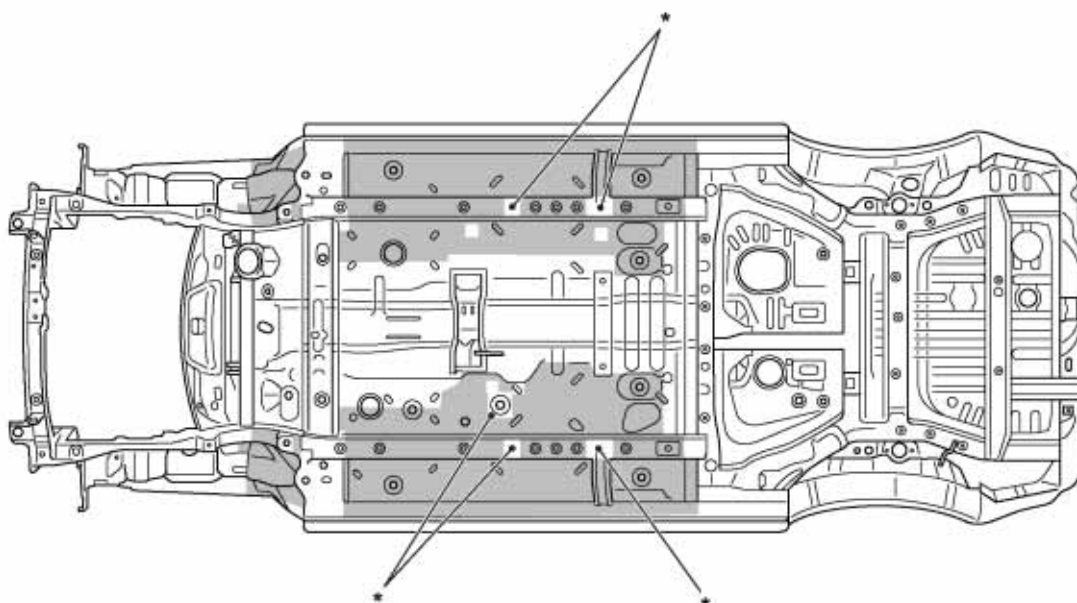
UNDERCOAT APPLICATION LOCATIONS

The under parts of the body is undercoated for anti-corrosive, anti-rust, anti-chipping, and anti-vibration performance.

■ : Undercoat [Film thickness is at least 0.8 mm]

After correcting the body, restore as shown in the instructions of the figure, if necessary.

Tape the areas marked with an asterisks to protect those areas from getting any undercoating on those areas.

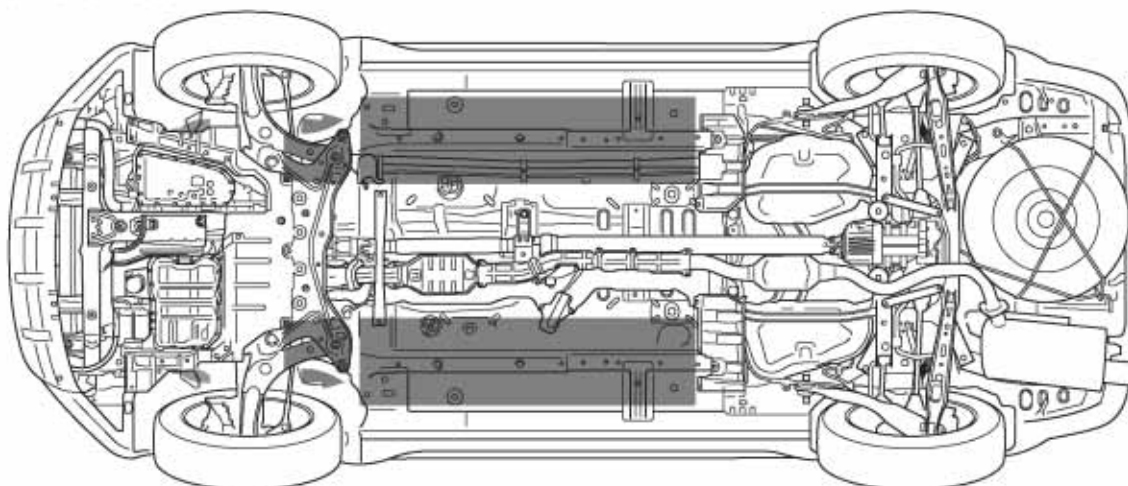
UNDERBODY ANTICORROSION AGENT LOCATIONS <SOME AREAS>

■ :0.1mm or more

In order to provide a greater corrosion resistance, underbody corrosion prevention treatment should be performed after undercoat application. After completing body repairs, restore this underbody corrosion prevention treatment as indicated in the illustration if necessary. Recommend wax:

- Tectyl 506T, 506 or S
- Waxoyl

- Take care not to permit the anticorrosion agent to come in contact with body painting, brake parts, exhaust pipes, bearing seals for rear axle and rambler parts (such as tires and drive shaft boots).
- If anticorrosion agent gets onto the oxygen sensor, it will cause a drop in the performance of the sensor. Cover the oxygen sensor with a protective material when applying anti-corrosion agents and undercoats.
