# SERVICE BULLETIN

| PURPOSE : INFORMATION | ISSUE NO. : MSB-07E42-009A | DATE : 2008-08-20 |
| SUBJECT : WELDED PANEL INSTALLATION PROCEDURES AND UNDERBODY ANTICORROSION AGENT | <div> <div>&lt;MODEL&gt;</div> <div>(EUR/RUSSIA)</div> <div>OUTLANDER</div> <div>(GS45X)(CW0W)</div> </div> <div> <div>&lt;M/Y&gt;</div> <div>07</div> </div> | |

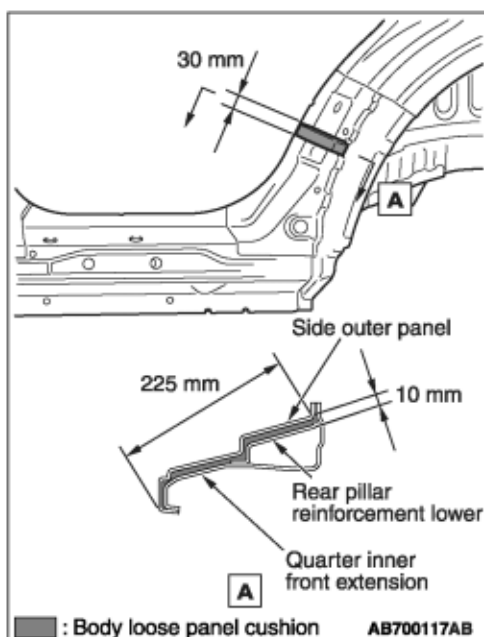
When installing the new floor side sill outer, the inside of wheel arch cannot be filled with sound dampening foam material, therefore, machine the body loose panel cushion (MR435765 or MR565301) shown in the figure as an alternative and adhere it.

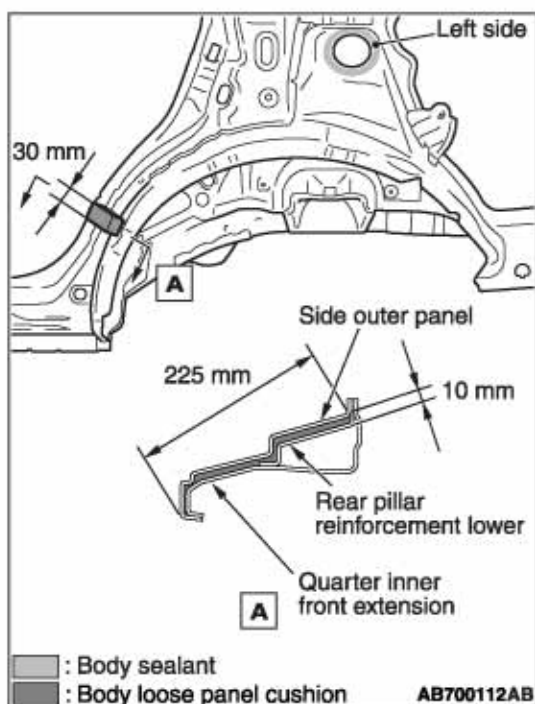
## QUARTER OUTER

The position and the size of the body loose panel cushion that is installed when installing the rear quarter outer panel have been changed as below.

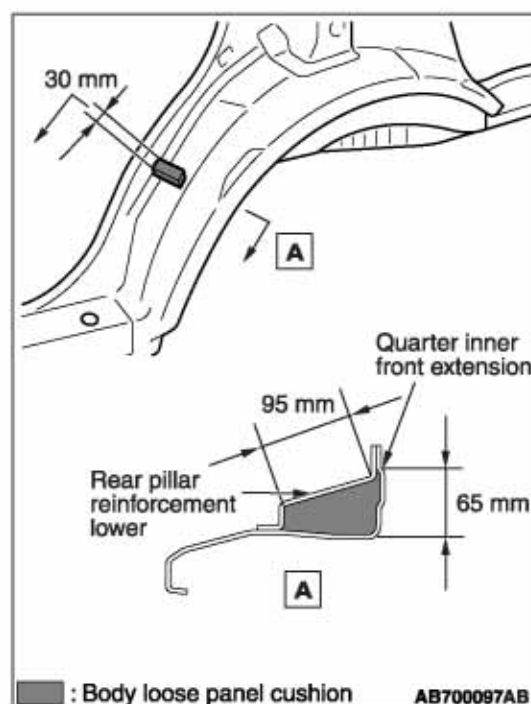
## QUARTER INNER

The position and the size of the body loose panel cushion that is installed when installing the rear pillar reinforcement lower have been changed as below.

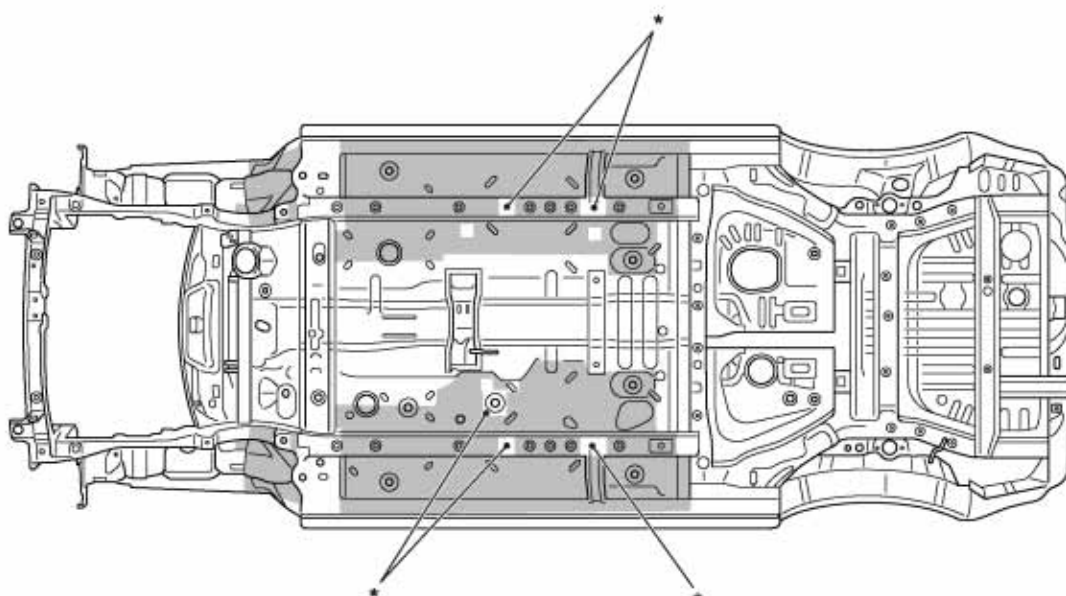
## UNDERCOAT APPLICATION LOCATIONS

■ : Undercoat [Film thickness is at least 0.8 mm]

After correcting the body, restore as shown in the instructions of the figure, if necessary.

Tape the areas marked with an asterisks to protect those areas from getting any undercoating on those areas.

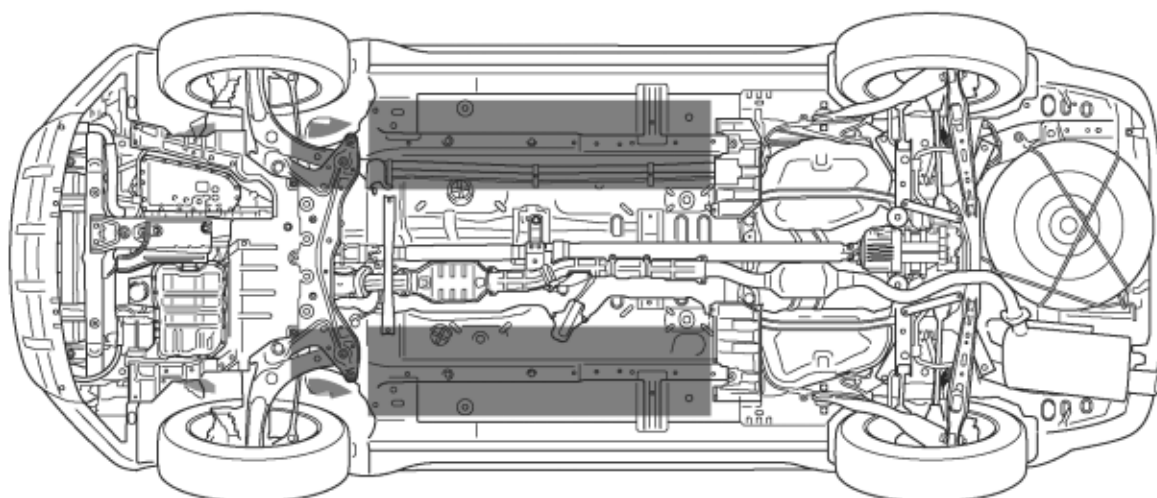
## UNDERBODY ANTICORROSION AGENT LOCATIONS <SOME AREAS>

■ :0.1mm or more

In order to provide a greater corrosion resistance, underbody corrosion prevention treatment should be performed after undercoat application. After completing body repairs, restore this underbody corrosion prevention treatment as indicated in the illustration if necessary. Recommend wax:
