SERVICE BULLETIN

PURPOSE : INFORMATION	ISSUE NO. : MSB-08E13-002B	DATE : 2008-03-20
SUBJECT : CAUTIONARY INSTRUCTION FOR ENGINE-ECU REMOVAL AND INSTALLATION	<div> <div><MODEL></div> <div>(EUR/RUSSIA)</div> <div>LANCER</div> <div>(GS41)(CY0A),</div> <div>OUTLANDER</div> <div>(GS45X)(CW0W)</div> </div> <div> <div><M/Y></div> <div>07-</div> </div>	
GROUP : FUEL

A cautionary instruction for the engine-ECU removal and installation is modified. This Service Bulletin contains the new instruction.

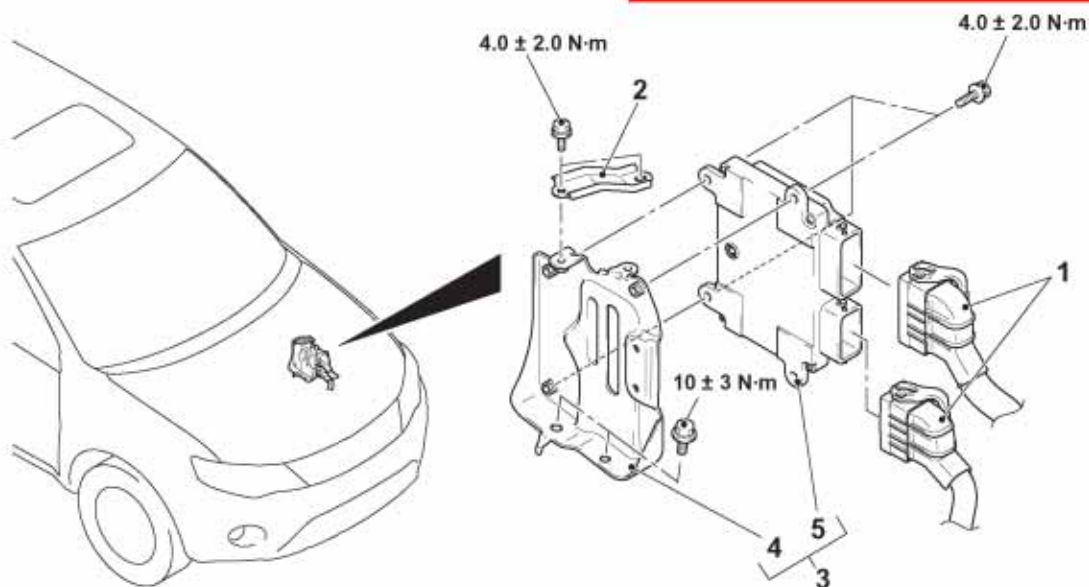
AC606213AB

- For replacement of the engine-ECU, use an engine-ECU for which the vehicle identification number entry and coding are completed. If diagnosis code No. P0630 chassis number not programmed or No. P1676 variant coding system is set in the engine-ECU, replace it with an engine-ECU to which the same vehicle identification number has been entered and the same coding has been made as for the relevant vehicle.

When the engine-ECU is replaced, save the chassis number and perform the variant coding.

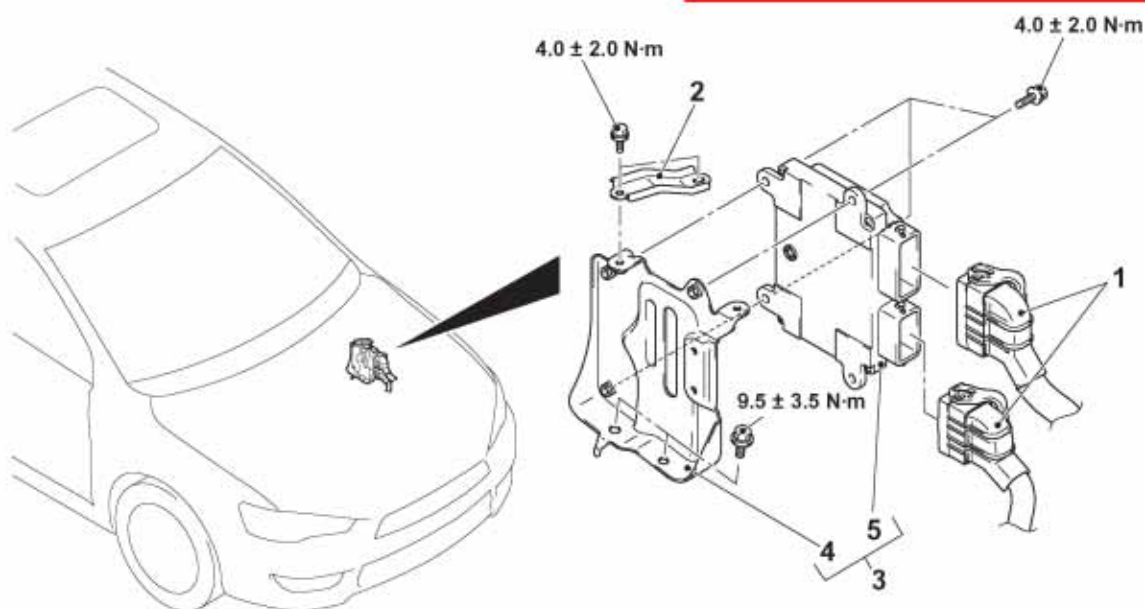
AC613515AB

- For replacement of the engine-ECU, use an engine-ECU for which the vehicle identification number entry and coding are completed. If diagnosis code No. P0630 chassis number not programmed or No. P1676 variant coding system is set in the engine-ECU, replace it with an engine-ECU to which the same vehicle identification number has been entered and the same coding has been made as for the relevant vehicle.

When the engine-ECU is replaced, save the chassis number and perform the variant coding.
