SERVICE BULLETIN

PURPOSE : CORRECTION	ISSUE NO. : MSB-08E23-502	DATE : 2008-02-05
SUBJECT : A/T FLUID TEMPERATURE SENSOR CHECK	<div> <div><MODEL></div> <div>(EUR)</div> <div>OUTLANDER</div> <div>(GS45X)(CW0W)</div> </div> <div> <div><M/Y></div> <div>07-</div> </div>	
GROUP : AUTOMATIC TRANSMISSION

A/T FLUID TEMPERATURE SENSOR CHECK

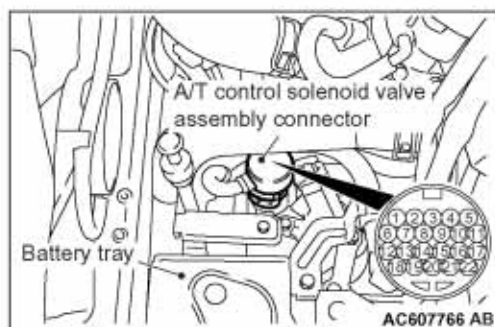
1. Disconnect the A/T control solenoid valve assembly connector. **and No. 3 <Added>**
2. Measure the resistance between the sensor-side connector terminal No. 2 of the A/T control solenoid valve assembly connector **and the earth.**

Standard value: **<Deleted>**

Fluid temperature °C	Resistance kΩ
10	Approx. 6.62
25	Approx. 3.51
80	Approx. 0.55
110	Approx. 0.25

The A/T fluid temperature sensor cannot be removed or replaced as a single unit. When the A/T fluid temperature sensor needs to be replaced, replace the valve body assembly.

3. When the resistance of the A/T fluid temperature sensor is outside the standard value, and the fluid temperature warning comes on/goes out at other than the specified temperatures, replace the valve body assembly and the harness.
