PURPOSE : CORRECTION	ISSUE NO. : MSB-09E54-502	DATE : 2009-06-05
SUBJECT : CONNECTOR NUMBER OF CORNER SENSOR/BACK SENSOR CONNECTOR	<div> <div><MODEL></div> <div>(EUR/RUSSIA)</div> <div>OUTLANDER</div> <div>(GS45X)(CW0W)</div> </div> <div> <div><M/Y></div> <div>07</div> </div>	
GROUP : CHASSIS ELECTRICAL

The connector number of the connector from the corner sensor/back sensor to ECU has been incorrect. This Service Bulletin contains the correct connector number.

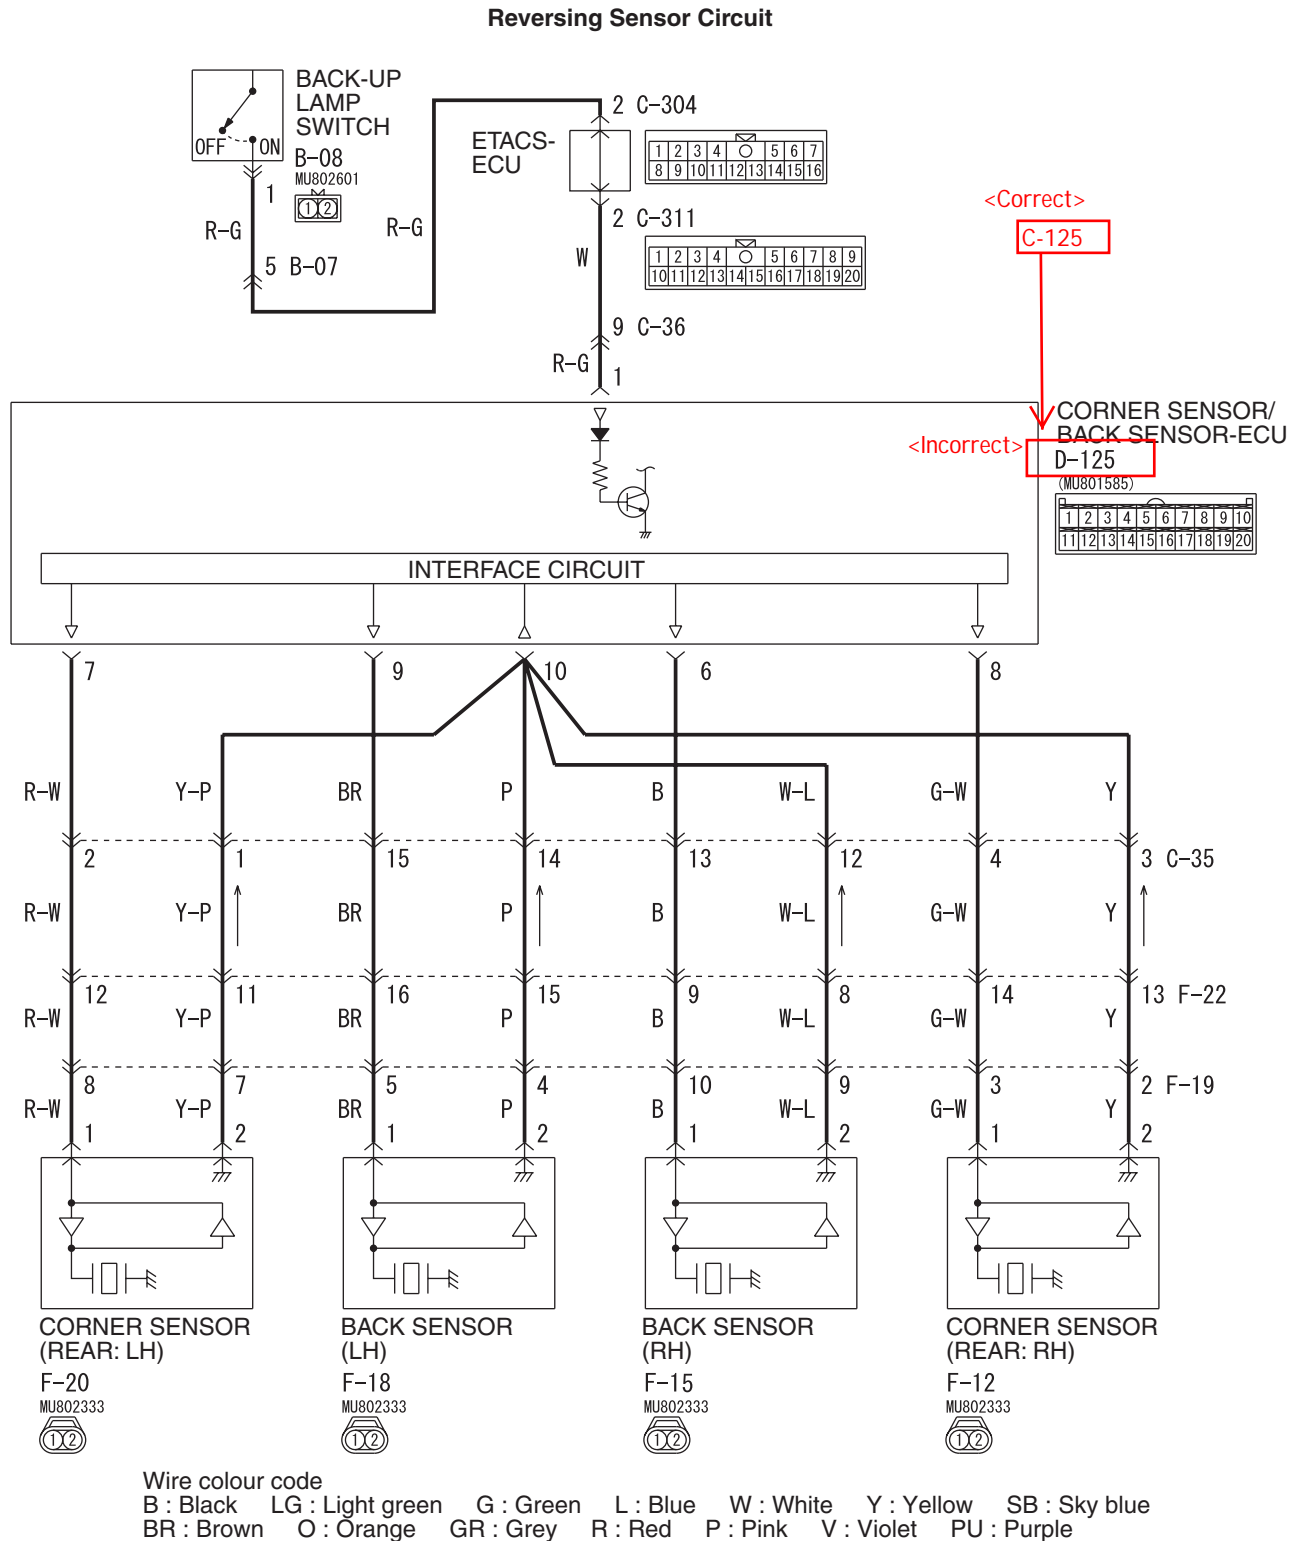
Inspection Procedure 5: Obstacle is not Detected even when The Selector Lever is Shifted to "R" (Reverse) Position.

<Correct> C-125 ← <Incorrect> D-125
