SERVICE BULLETIN

PURPOSE : CORRECTION	ISSUE NO. : MSB-10E42_90-501	DATE : 2010-04-20
SUBJECT : KOS TROUBLESHOOTING	<div> <div><MODEL></div> <div>(EUR/RUSSIA)</div> </div> <div> <div><M/Y></div> <div>07</div> </div>	
GROUP : KEYLESS OPERATION SYSTEM (KOS)/ CIRCUIT DIAGRAMS	<div>OUTLANDER</div> <div>(CW0W)</div>

2007 Workshop manual: In "Inspection procedure 4: IG knob will not turn" of KOS Troubleshooting, terminal numbers for checking continuity of push switch has been incorrect. This Service Bulletin contains the correct terminal numbers.

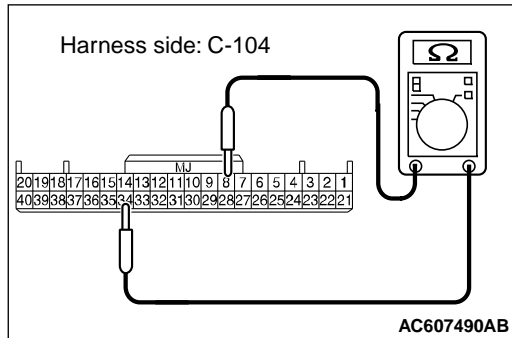
STEP 5. Ignition push switch check

- (1) Disconnect the KOS-ECU connector C-104.
- (2) With the IG knob push switch pressed, measure the resistance at the harness-side connector.

- (3) Resistance between the KOS-ECU connector C-104 terminal No. 8 and 34.

OK: Continuity exists (2 Ω or less)

<Correct>

4/10

<Incorrect>

8/34

NO : Check the C-104 KOS-ECU connector, the C-211 key reminder switch connector, the C-317 ETACS-ECU connector, and the wiring harness between the C-104 KOS-ECU connector (terminal No. 5/8) and the C-211 key reminder switch connector (terminal No. 9/4), and between the C-211 key reminder switch connector (terminal No. 1) and the C-317 ETACS-ECU connector (terminal No. 10), and repair them if necessary. If they are normal, replace the key reminder switch.

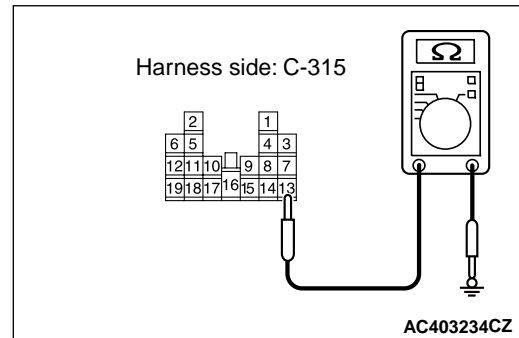
STEP 6. Key reminder switch check

ignition key cylinder.

- (3) Check the continuity between the C-315 ETACS-ECU connector terminal No. 13 and the earth.

OK: Continuity exists (2 Ω or less)

- (1) Disconnect the C-315 ETACS-ECU connector.
- (2) Measure the resistance at the harness-side connector with the ignition key removed from the

NO : Check the C-211 key reminder switch connector, the C-315 ETACS-ECU connector, the wiring harness between the C-211 key reminder switch connector (terminal No. 3) and the C-315 ETACS-ECU connector (terminal No. 13), and between the C-211 key reminder switch connector (terminal No. 2) and the earth. If they are normal, replace the key reminder switch.
