SERVICE BULLETIN

DOMESTIC SALES & AFTER SALES SERVICE OFFICE, MITSUBISHI MOTORS CORPORATION

PURPOSE : INFORMATION	ISSUE NO. : MSB-10E13_17-001	DATE : 2010-06-05
SUBJECT : DPF-RELATED SERVICE PROCEDURES FOR 4N1	<MODEL> <M/Y>	
GROUP : FUEL/ENGINE & EMISSION CONTROL	(EUR) See following 2. Applicable Manuals table.

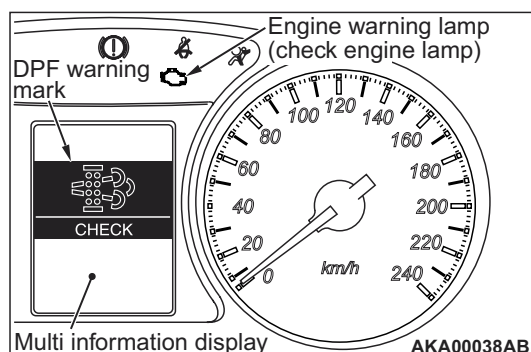
DPF WARNING SIGNAL

When the anticipated PM accumulation becomes larger in amount and reaches the specified level, the engine-ECU encourages the driver to drive under the driving conditions required for the DPF regeneration by showing the DPF warning mark on the multi information display. When the PM accumulated in the DPF reaches its clogged or damaged level, the engine-ECU warns the driver that the vehicle must be brought to the workshop by showing the DPF warning mark in the multi information display and illuminating the engine warning lamp. When the vehicle is brought into the shop with the DPF warning mark shown, service the vehicle in accordance with the following procedures.

DPF warning mark	Engine warning lamp	State and service
Shown	Being lit <Changed>	The forcible DPF regeneration, using M.U.T.-III, must be carried out because it is assumed that PM is excessively accumulated within the DPF. NOTE: At that time, the engine-ECU stores the diagnosis code P1498.
Shown	Not being lit	The status is that the driver is advised to drive the vehicle under the driving conditions in which the DPF automatic regeneration can be carried out because it is assumed that the PM is accumulated more than the specified value in the DPF. In this case, the DPF regeneration must be carried out using one of the following two methods: <ul style="list-style-type: none"> • After the engine warm-up, the vehicle must be driven at more than 40 km/h until the DPF warning mark is extinguished. The driving time is approximately 20 minutes. It is all right that the vehicle or the engine stops during the driving. • Using the MUT-III, the forcible DPF regeneration must be carried out.

The engine-ECU estimates that the PM will excessively be accumulated in the DPF.
At that time, the engine-ECU should store the diagnosis codes (P1498, P2463). Carry out the troubleshooting regarding the stored diagnosis codes (Refer to GROUP 13 Diesel Fuel <4N1> - Troubleshooting - Diagnosis Code Chart).
