SERVICE BULLETIN

PURPOSE: CORRECTION	ISSUE NO.: MSB-11E35-501	DATE: 2011-07-05	
SUBJECT: DIAGNOSIS CODE C2100 TROUBLESHOOTING PROCEDURE		<model> (EUR/RUSSIA) LANCER</model>	<m y=""> 07–11</m>
GROUP : ANTI-SKID BRAKING SYSTEM (ABS)		(CY0A), OUTLANDER (CW0W)

Some of the troubleshooting procedure steps for diagnosis code C2100 have been incorrect in the applicable Workshop Manuals. This Service Bulletin contains the corrected descriptions.

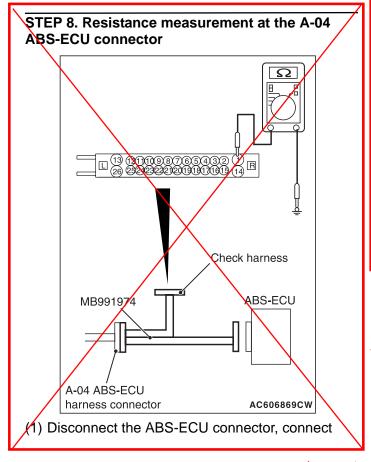
special tool ABS check harness (MB991974) to the harness-side connector, and then measure the resistance at the special tool connector side. NOTE: Do not connect the special tool ABS check harness (MB991974) to ABS-ECU.

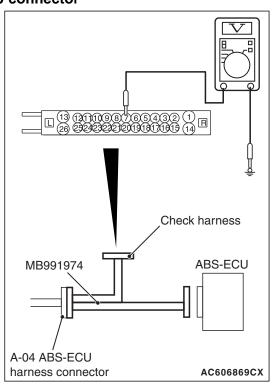
STEP 8. Voltage measurement at the A-04 ABS-ECU connector

- (1)Disconnect the ABS-ECU connector, connect special tool ABS check harness (MB991974) to the harness-side connector, and then measure the voltage at the special tool connector side.

NOTE: Do not connect the special tool ABS check harness (MB991974) to ABS-ECU.
- (2) Turn the ignition switch to the "ON" position.
- (3) Voltage between terminal No.7 and body earth.

YES: The open circuit may be present in the power supply circuit. Repair the wiring harness between the A-04 ABS-ECU connector terminal No.7 and C-317 ETACS-ECU connector terminal No.5, fuse No.12. Or replace the ETACS-ECU (Refer to GROUP 54A – ETACS-ECU).

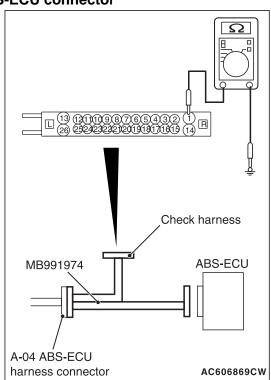
STEP 10. Resistance measurement at the A-04 ABS-ECU connector

- (1)Disconnect the ABS-ECU connector, connect special tool ABS check harness (MB991974) to the harness-side connector, and then measure the resistance at the special tool connector side.

NOTE: Do not connect the special tool ABS check harness (MB991974) to ABS-ECU.
- (2)Resistance between terminal No.1 and body earth, and between terminal No.14 and body earth.

YES: The open circuit may be present in the power supply circuit. Repair the wiring harness between the A-04 ABS-ECU connector terminal No.1 and body earth, and between the A-04 ABS-ECU connector terminal No.14 and body earth.

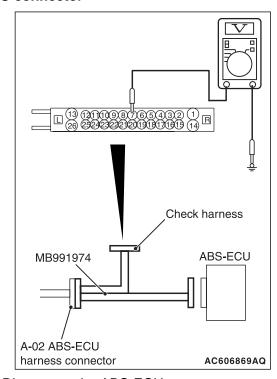
STEP 5. Voltage measurement at the A-02 ABS-ECU connector

(1) Disconnect the ABS-ECU connector, connect special tool ABS check harness (MB991974) to the harness-side connector, and then measure the resistance at the special tool connector side.

NOTE: Do not connect the special tool ABS check harness (MB991974) to ABS-ECU.

YES: The open or short circuit may be present in the power supply circuit. Repair the wiring harness between the A-02 ABS-ECU connector terminal No. 7 and the fusible link No. 33

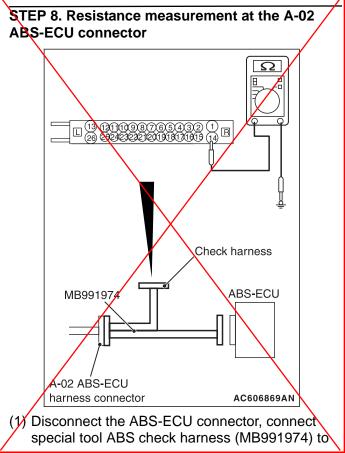
the harness-side connector, and then measure the resistance at the special tool connector side. NOTE: Do not connect the special tool ABS

check harness (MB991974) to ABS-ECU. (2) Resistance between terminal No.1 and body earth, and between terminal No.14 and body earth.

YES: The open circuit may be present in the power supply circuit, Repair the wiring harness between the A-02 ABS-ECU connector terminal No.1 and body earth, and between the A-02 ABS-ECU connector terminal No.14 and body earth.

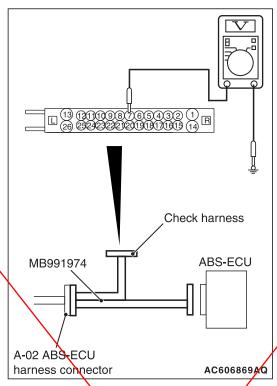
STEP 8. Voltage measurement at the A-02 ABS-ECU connector

(1)Disconnect the ABS-ECU connector, connect special tool ABS check harness (MB991974) to the harness-side connector, and then measure the voltage at the special tool connector side.

NOTE: Do not connect the special tool ABS check harness (MB991974) to ABS-ECU.

YES: The open circuit may be present in the power supply circuit. Repair the wiring harness between the A-02 ABS-ECU connector terminal No.7 and C-317 ETACS-ECU connector terminal No.5, fuse No.12. Or replace the ETACS-ECU (Refer to GROUP 54A – ETACS-ECU).

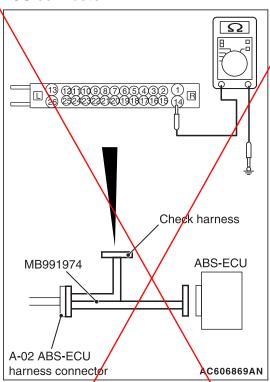
STÉP 10. Resistance measurement at the A-02 ABS-ECU connector

(1)Disconnect the ABS-ECU connector connect special tool ABS check harness (MB991974) to the harness-side connector, and then measure the resistance at the special tool connector side.

NOTE: Do not connect the special tool ABS check harness (MB991974) to ABS-ECU.

YES: The open circuit may be present in the power supply circuit. Repair the wiring harness between the A-02 ABS-ECU connector term nal No.1 and body earth, and between the A-02 ABS-ECU connector terminal No.14 and body earth.

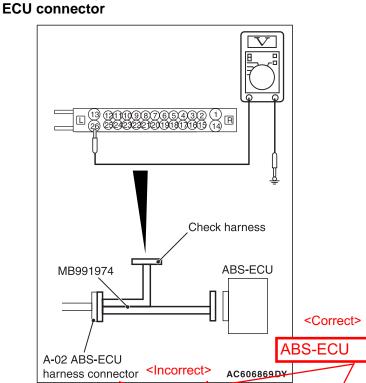
- (1) Disconnect the ASC-EGU connector, connect special tool ABS check harness (MB991974) to the harness-side connector, and then measure the voltage at the special tool connector side.

NOTE: Do not connect the special tool ABS check harness (MB991974) to ASC-ECT.
- (2) Measure the voltage between terminal No.26 and body earth.

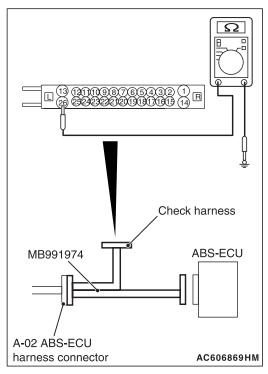
STEP 7. Resistance measurement at A-02 ABS-ECU connector

(1) Removal the fusible link No.27.

(2) Disconnect the ABS-ECU connector, connect special tool ABS check harness (MB991974) to the harness-side connector, and then measure

NO: The open circuit may be present in the power supply circuit. Repair the wiring harness between the A-02 ABS-ECU connector terminal No.26 and the fusible

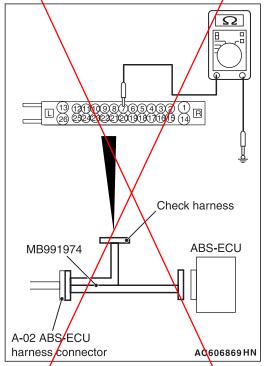
STEP 10. Resistance measurement at A-02 ABS-ECU connector

(1) Disconnect the C-317 ETACS-ECU connector.

(2) Disconnect the ABS-ECU connector, connect special tool ABS check harness (MB991974) to the harness-side connector, and then measure the resistance at the special tool connector side.

NOTE: Do not connect the special tool ABS check harness (MB991974) to ABS-ECU.

NO: The short circuit may be present in the power supply circuit. Repair the wiring harness between the A-02 ABS-ECU connector terminal No.7 and the C-317 ETACS-ECU connector terminal No.5, and then replace the fuse No.12. Then go to Step 20.

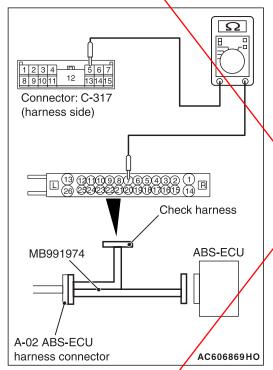
STEP 15. Resistance measurement at A-02 ABS-ECU connector

(1) Disconnect the C-317 ETACS-ECU connector.

(2) Disconnect the A-02 ABS-ECU connector, connect special tool ABS check harness (MB991974) to the harness-side connector, and then measure the resistance at the special tool connector side.

NOTE: Do not connect the special tool ABS check harness (MB991974) to ABS-ECU.

NO: The open circuit may be present in the power supply circuit. Repair the wiring harness between the A-02 ABS-ECU connector terminal No.7 and the C-317 ETACS-ECU connector terminal No.5. Then go to Step 20.

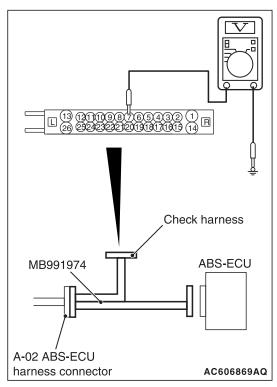
STEP 9. Voltage measurement at the A-02 ABS-ECU connector

- (1)Disconnect the ABS-ECU connector, connect special tool ABS check harness (MB991974) to the harness-side connector, and then measure the voltage at the special tool connector side.

NOTE: Do not connect the special tool ABS check harness (MB991974) to ABS-ECU.
- (2) Turn the ignition switch to the "ON" position.
- (3) Voltage between terminal No.7 and body earth.

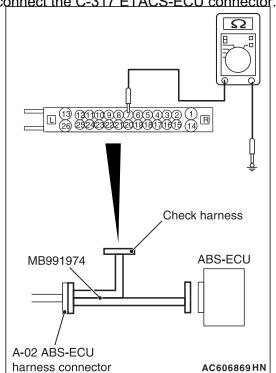
(1) Disconnect the C-317 ETACS-ECU connector.

- (2)Disconnect the ABS-ECU connector, connect special tool ABS check harness (MB991974) to the harness-side connector, and then measure the resistance at the special tool connector side.

NOTE: Do not connect the special tool ABS check harness (MB991974) to ABS-ECU.
- (3)Resistance between the terminal No.7 and body earth.

NO: The short circuit may be present in the power supply circuit. Repair the wiring harness between the A-02 ABS-ECU connector terminal No.7 and the C-317 ETACS-ECU connector terminal No.5, and then replace the fuse No.12. Then go to Step 21.

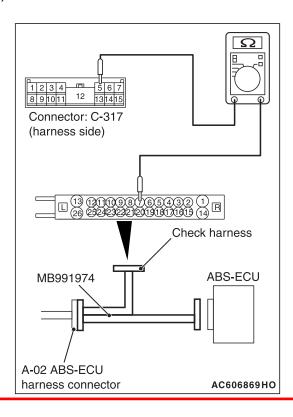
STEP 16. Resistance measurement at the A-02 ABS-**ECU** connector

(1)Disconnect the C-317 ETACS-ECU connector

- (2)Disconnect the A-02 ABS-ECU connector, connect special tool ABS check harness (MB991974) to the harness-side connector, and then measure the resistance at the special tool connector side. NOTE: Do not connect the special tool ABS check harness (MB991974) to ABS-ECU.
- (3)Resistance between the A-02 ABS-ECU connector terminal No.7 and the C-317 ETACS-ECU connector terminal No.5.

OK: Continuity exists (2 Ω or less)

NO: The open circuit may be present in the power supply circuit. Repair the wiring harness between the A-02 ABS-ECU connector terminal No.7 and the C-317 ETACS-ECU connector terminal No.5. Then go to Step 21.
