# **SERVICE BULLETIN**

GLOBAL AFTER SALES OFFICE, MITSUBISHI MOTORS CORPORATION

PURP	POSE: Modifications	ISSUE NO.: MSB-16EXML42_52_54-001	DATE: 2016-11-21	
SUBJ	ECT: Modifications of t and additional co	<destination model=""> (As per attached sheet 1)</destination>	<m y=""> ~17</m>	
GROU	UP : Gr:42(Body)/52(Inter	As per attached sheets 2 & 3

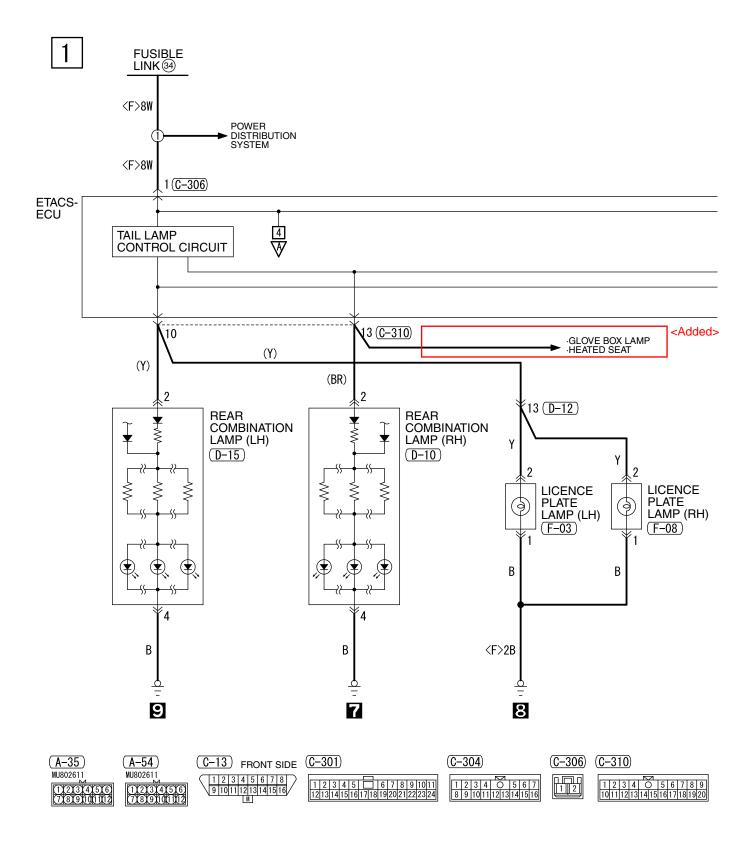
H6G08X05AC

## TAIL LAMP, POSITION LAMP, LICENCE PLATE LAMP AND LIGHTING MONITOR BUZZER

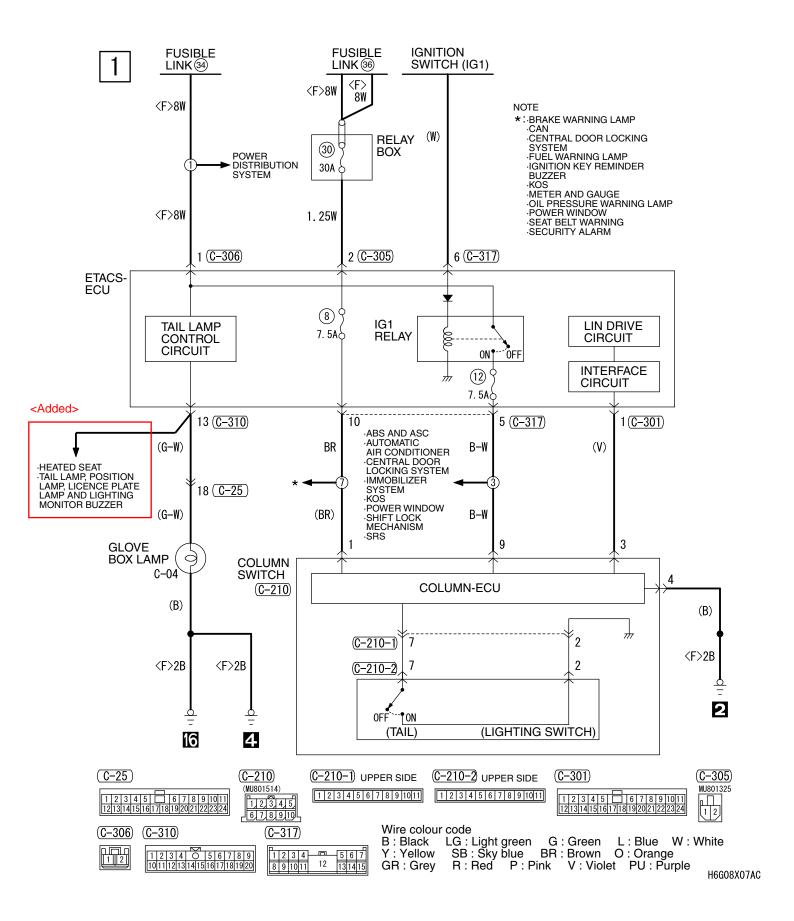
## **GLOVE BOX LAMP**

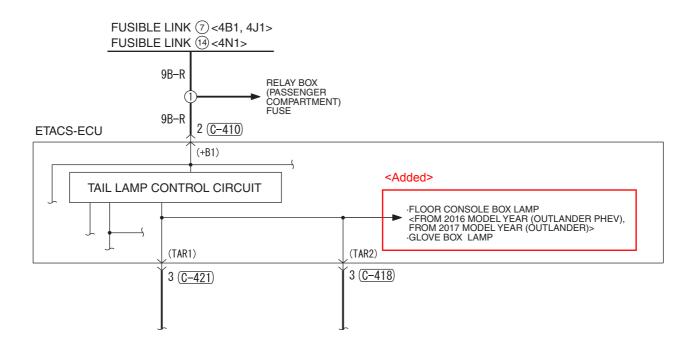
## TAIL LAMP, POSITION LAMP, LICENCE PLATE LAMP AND LAMP REMINDER BUZZER

Note: The circuit diagram above shows 2017 model year OUTLANDER as a typical circuit.

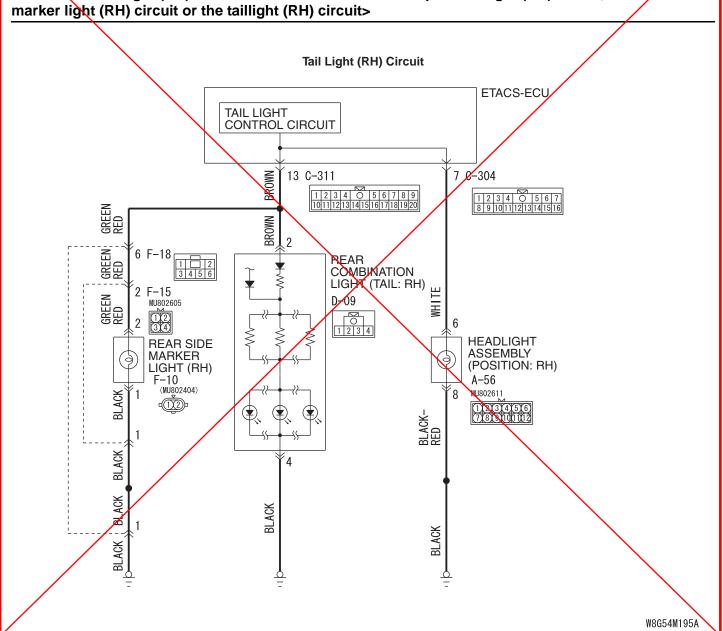
DTC B16A0: Taillight (RH) circuit open <Open circuit in the position light (RH) circuit, rear side marker light (RH) circuit and the taillight (RH) circuit>

DTC B16A7: Taillight (RH) circuit short <Short circuit in the position light (RH) circuit, rear side marker light (RH) circuit or the taillight (RH) circuit>

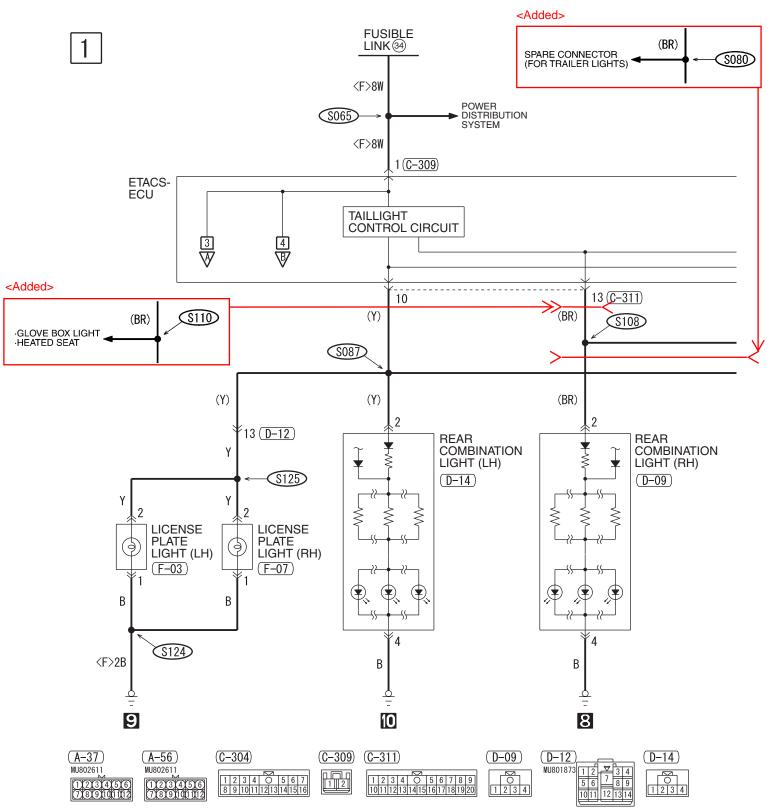
## TAILLIGHT, POSITION LIGHT, REAR SIDE MARKER LIGHT, LICENSE PLATE LIGHT AND LIGHTING MONITOR TONE ALARM

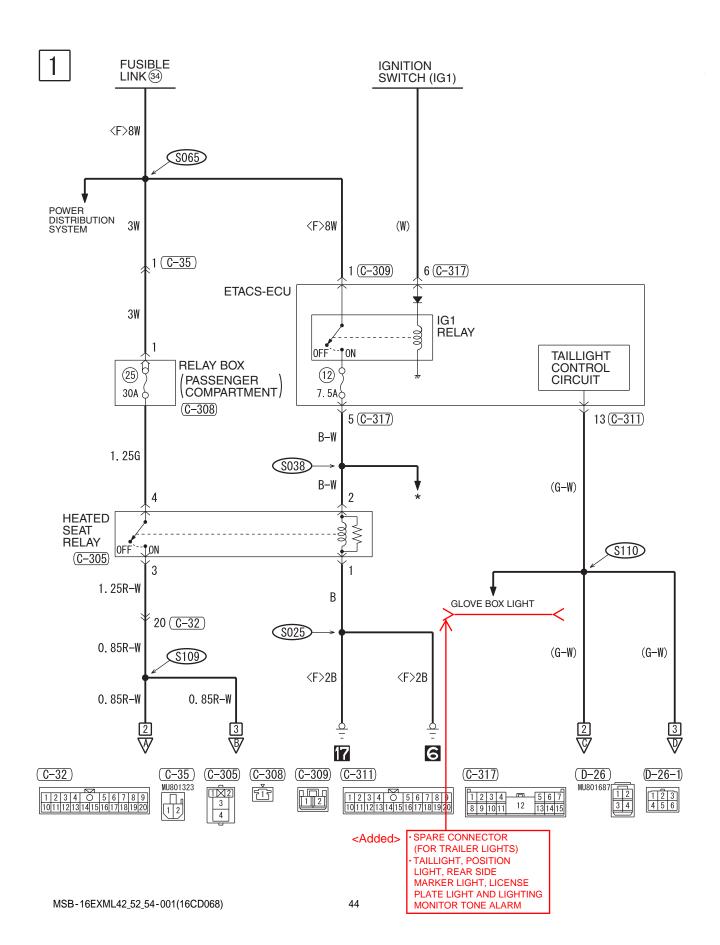
#### **HEATED SEAT**

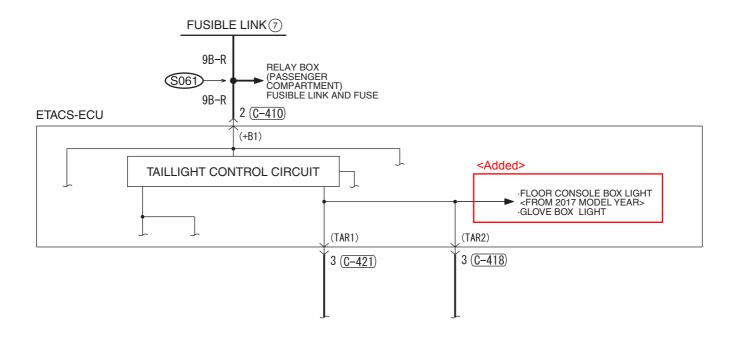
### TAILLIGHT, POSITION LIGHT, SIDE MARKER LIGHT, LICENSE PLATE LIGHT AND LIGHT REMINDER TONE ALARM

Note: The circuit diagram above shows 2017 model year as a typical circuit.
